Manhole Inspection Summary

Manhole # S4100_032MH

Insp Date: **2/21/07 2:26 PM**

Location Address: **2301 AISQUITH ST**

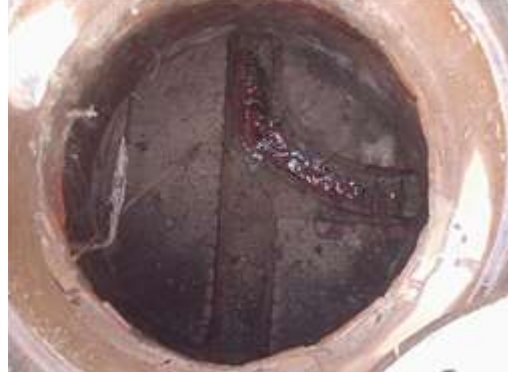
Top View

Corroded and missing steps. Evidence of surcharge - Bench debris. Channel debris.

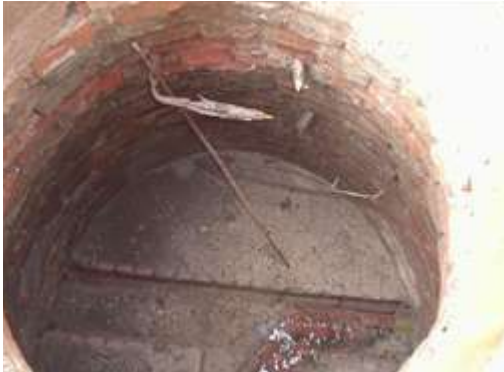
Defect

Frame leaks. Adjustment deterioration, cracks and infiltration. Corbel and Barrel infiltration - other side.

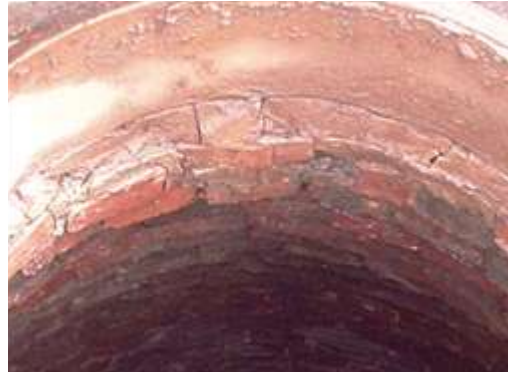
Defect

Frame leaks. Adjustment deterioration, cracks and infiltration. Corbel and Barrel infiltration.

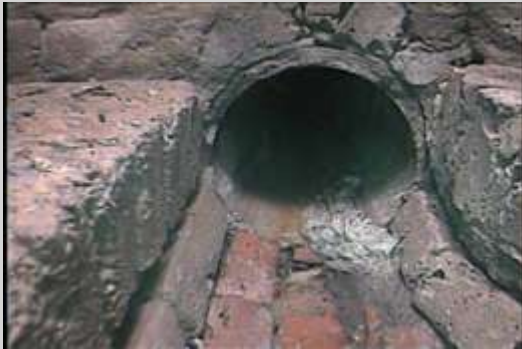
8 in. Circular Gravity Sewer Pipe Out @ 12 O'Clock

Barrel deterioration and infiltration. Channel deterioration.

Deposits: ☐ None ☐ Mud ☐ Sludge ☒ **Debris** ☐ Grease

Infiltration: **None** Pipe Seal Cond: **Cracked**

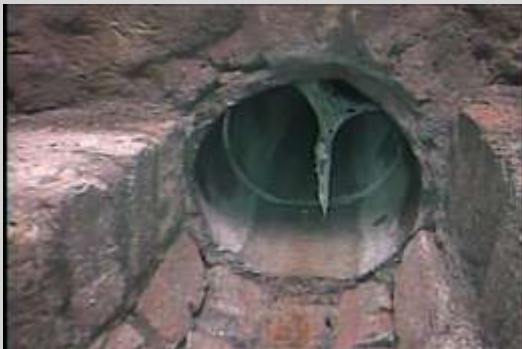
8 in. Circular Gravity Sewer Pipe In @ 3 O'Clock

Infiltration: **Evidence** Pipe Seal Cond: **Cracked**

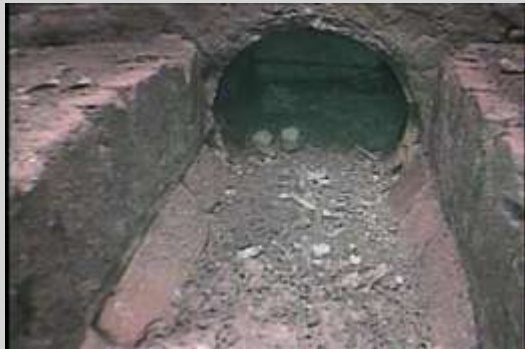
Pipe In @ 6 O'Clock

Capped.

Connects To: **Stub connection / abandoned**
☐ Possible Illicit Connection
